Silicon Anomaly List

ADSP-TS203S

ABOUT ADSP-TS203S SILICON ANOMALIES

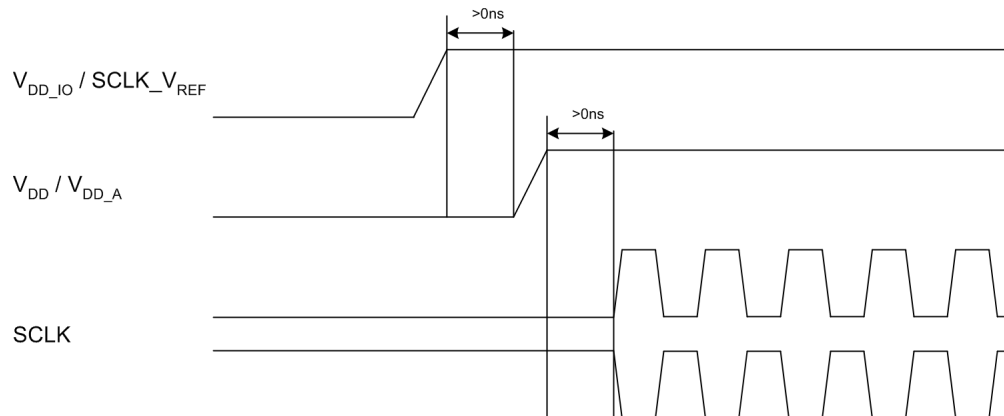
56. 03000373 - PLL Failure to Lock at Power-Up:**DESCRIPTION:**

The PLL may fail to lock correctly to the SCLK input during power-up.

V_{DD}/V_{DD_A} must be held low until after V_{DD_IO} and SCLK_V_{REF} are stable and within specification. Additionally, SCLK must be held high or low until after V_{DD}/V_{DD_A} is stable and within specification. The following figure illustrates the workaround:
