MAX32690 ERRATA SHEET

Revision A2 Errata

419-100107; Rev 2; 1/24

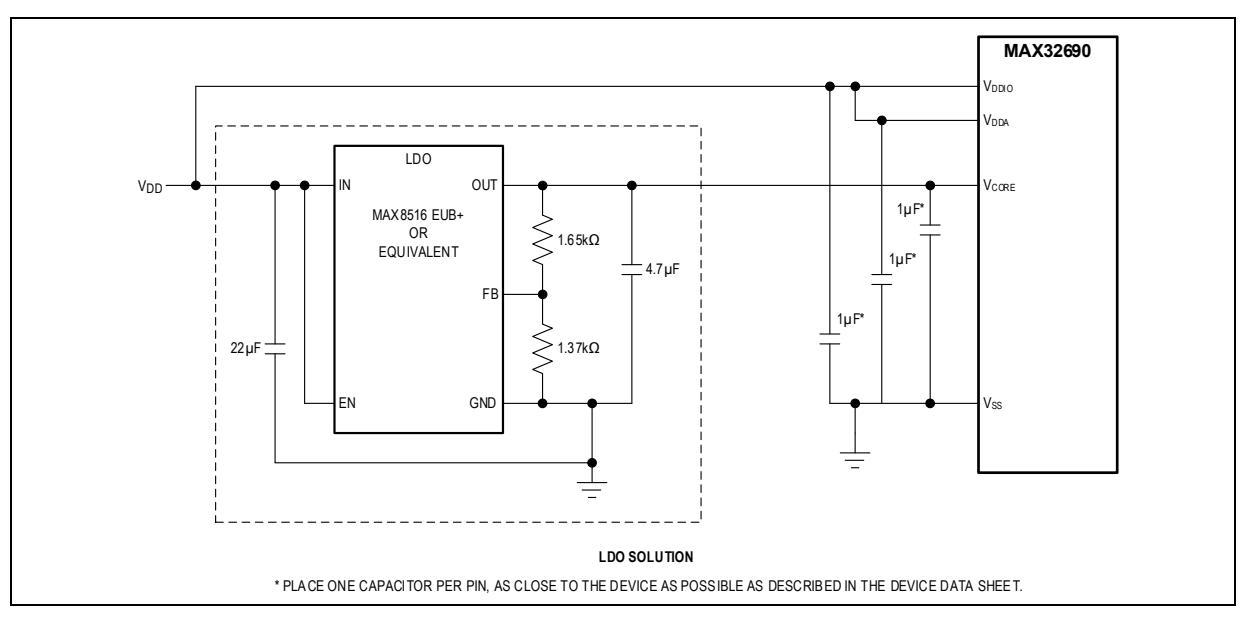
6) FLASH MEMORY MAY BE CORRUPTED DURING POWER-DOWN WHEN OPERATING IN DUAL-SUPPLY MODE

Incorrect sequencing of the V_{DDIO} and V_{CORE} supplies can corrupt the flash memory contents.

- 1. Control the power supplies so that:
 - VCORE ≥ VCORE(MIN) before VDDIO > VRST(VDDIOMIN) on power-up
 - V_{DDIO} < V_{RST(VDDIOMIN)} before V_{CORE} ≤ V_{CORE(MIN)} on power-down
- or
- 2. Ensure RSTN is asserted active whenever $V_{CORE} \leq V_{CORE(MIN)}$.

V_{DDA} must be connected to V_{DDIO} as originally stated in the data sheet.

Workaround #1 can be implemented using an LDO such as the MAX8516 or equivalent as shown. The LDO is guaranteed to regulate its output, which drives V_{CORE} well below $V_{RST(VDDIOMIN)}$.
