Analyzing and Solving Fixed Frequency Spur Issues in High Precision ADC Signal Chains

By Steven Xie

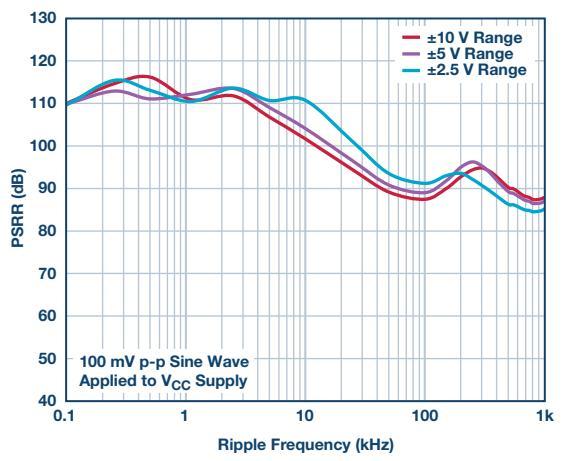
Figure 1. AD7616 PSRR vs. ripple frequency.

The AD7616 is a 16-bit DAS that supports dual-simultaneous sampling of 16 channels for power line monitoring. It has a very high PSRR and will do a good job of rejecting/attenuating the switching ripple. For example, a dc-to-dc switching power supply with 100 mV p-p ripple noise at 100 kHz is used for AD7616, a V_{cc} 5 V with ±10 V input range.

The digital code noise caused by the ripple noise is:

$$\frac{100 \text{ mV } p-p}{10^{\frac{88 \text{ dB}}{20}}} = 3.98 \text{ } \mu\text{V} \text{ } or \text{ } 0.013 \text{ LSB}$$

This level of ripple showing up in the ADC output is extremely low for a 16-bit converter. High PSRR performance in ADCs makes it possible to use switching regulators in precision measurement systems.

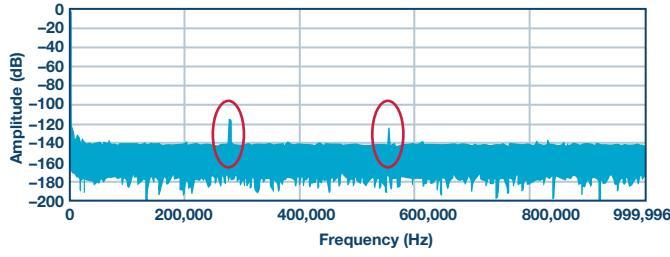
Figure 2. Spur issue as seen on an EVAL-AD4003FMCZ eval board.

The AD4003 is a low noise, low power, high speed 18-bit, 2 MSPS precision successive approximation register (SAR) ADC. During EVAL-AD4003FMCZ evaluation board ac performance testing, a spur at a level of about -115 dBFS was found at around 277.5 kHz; the spur and its second harmonic appeared as shown in Figure 2.

First, it was confirmed that the AD4003 power supplies were not causing the spurs.

Then, tests were performed to determine if the spurs were coming from the analog input.

- The spurs decreased when the differential analog input conditioning circuitry was removed.
- The spurs decreased when a narrow bandwidth RC filter (such as 1 kΩ, 10 nF) was inserted at the front end of AD4003 buffer amplifier, ADA4807-1.

These results show that the noise causing the spurs may pass through the conditioning circuitry and into the AD4003's analog inputs. Next, the sensor output was disconnected and the conditioning circuitry removed, leaving only the $V_{\text{REF}}/2$ CM voltage input at the noninverting input of the ADA4807-1. However, the spurs remained and at a similar level.

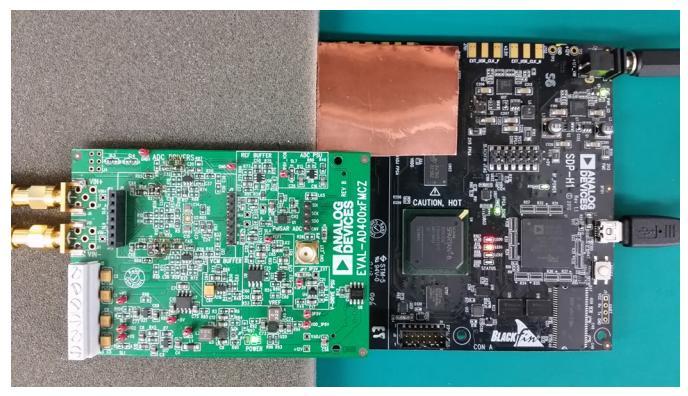
Figure 3. VADJ_FMC inductor L5 covered by copper foil shield.

It was then suspected that the interference source was located around the EVAL-AD4003FMCZ signal chain. To prove this, a copper foil shield was placed at various locations on the EVAL-AD4003FMCZ board and the controller SDP-H1 board. It was determined that when the copper foil shield was placed over the dc-to-dc power supplies on the SDP-H1 board, as shown in Figure 3, the spurs would disappear. The spur frequency of 277.5 kHz matches the programmed switching frequency of the ADP2323 regulator. Figure 4 shows the 3.3 V VADJ_FMC switching frequency power as captured by the EVAL-AD7616SDZ GUI FFT.

The conclusion was reached that the dc-to-dc switching frequency interference was being emitted by the 8.2 μ H inductor, L5. The interference was being injected into the signal chain at the input of buffer amplifier ADA4807-1, where it then went into the AD4003 ADC's analog input.

- Use a low-pass filter at the front end of the AD4003 ADC to attenuate the coupled dc-to-dc switching frequency interference to a level that meets the design target (that is, spur buried in noise floor) if the application bandwidth allows it.
- Use the new SDP-H1 board (BOM Rev 1.4), which uses a shielded inductor for L5. The radiated interference power is reduced, so the spurs captured in AD4003 ADC's spectrum are much lower.
- The VADJ_FMC voltage level can be programmed by the EEPROM on the EVAL-AD4003FMCZ board. It was found that using a lower voltage level, such as 2.5 V for VADJ_FMC, caused the spurs to disappear also.

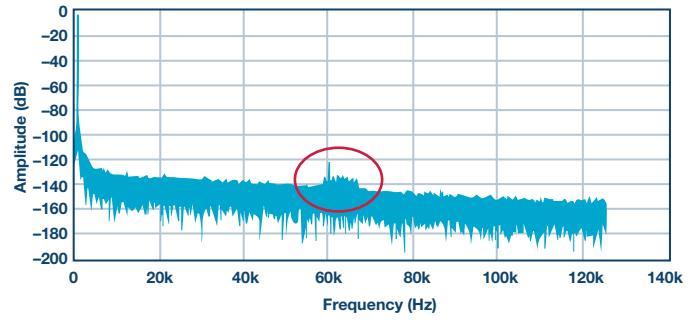
Figure 5. Spur issue as seen on EVAL-AD7175-2SDZ eval board.

The AD7175-2 is a low noise, fast settling, multiplexed, 2-/4-channel (fully/pseudo differential) Σ - Δ ADC for low bandwidth inputs. During the EVAL-AD7175SDZ evaluation board's signal chain test, a cluster of spurs around 60 kHz was captured, as shown in Figure 5.

This calculated -134 dBFS level is very close to the level of the captured -130 dBFS cluster of spurs (not including the highest narrow spur) shown in Figure 5. This verifies that the cluster of spurs is caused by the ac-to-dc adaptor's switching ripple feeding through the external reference ADR445. The remaining narrow spur will be resolved in the subsequent section.

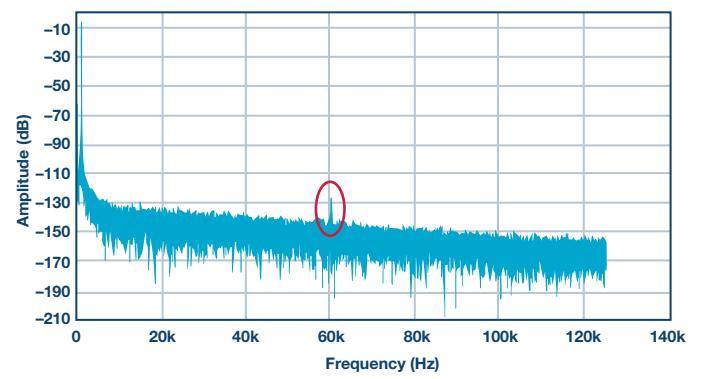
Figure 7. The cluster of spurs removed on EVAL-AD7175-2SDZ eval board.

The AD7175-2 ADC's power supplies and analog conditioning circuitries were evaluated and found to be good. However, as shown in Figure 6, the AD7175-2's 5 V reference input is generated by the ADR445 reference that is supplied by a 9 V dc from an ac-to-dc adaptor that is external to the evaluation board. Next, a bench 9 V dc power module was substituted for the adaptor. As a result, the cluster of spurs disappeared, leaving only a narrow spur at 60 kHz.

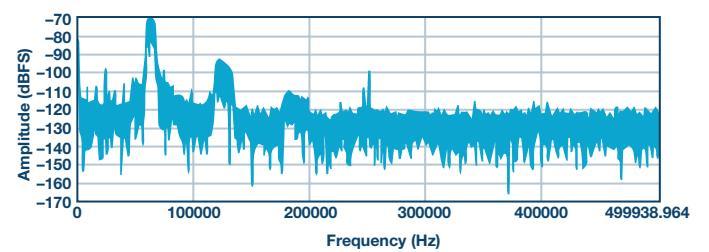
Figure 8. 3.3 V VADJ_FMC switching ripple captured by EVAL-AD7616SDZ GUI FFT.

The 9 V output ac-to-dc adaptor was tested with the EVAL-AD7616SDZ GUI FFT while supplying the EVAL-AD7175-2SDZ board with 320 mA of current output. The switching frequency power at the ADR445 reference's power pin is about -70 dBFS with an AD7616 \pm 10 V input range, which means 6.325 mV p-p or -64 dBFS at an AD7175-2 \pm 5 V input range.

$$20 \text{ V} \times 10^{\frac{-70 \text{ dB}}{20}} = 6.325 \text{ mV p-p}$$
$$20 \times \log \left(\frac{6.325 \text{ mV p-p}}{10 \text{ V}}\right) = -64 \text{ dBFS}$$

This power switching ripple noise feeds into the AD7175-2 ADC and shows up in the digital codes with some attenuation as stated below:

- ▶ The ADR445 reference's data sheet specifies a PSRR of 49 dB at 60 kHz.
- \blacktriangleright The ADR445 reference's output impedance is about 4.2 Ω at 60 kHz. It combines with the 4.8 μF reservoir caps, giving a further 18 dB of attention.
- Additionally, the AD7175-2 ADC's digital filter sinc5 + sinc1 adds about -3 dB of attenuation at 60 kHz, when ODR is 256 kSPS.

-64 dBFS - 49 dB - 18 dB - 3 dB = -134 dBFS

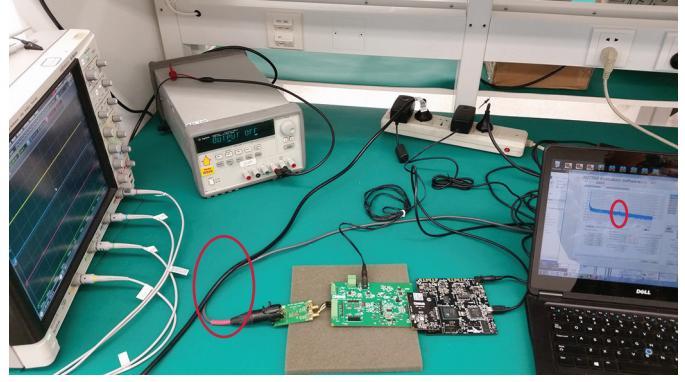
Figure 9. Spur caused by oscilloscope power supply cable.

During the investigation of the remaining narrow spur on the EVAL-AD7175-2SDZ evaluation board's spectral output, it was noticed that there was a digital oscilloscope operating on the test bench. As shown in Figure 9, the scope's 220 V ac power supply cable (the black one) was overlapping the EVAL-AD7175-2SDZ EVB's analog input cable (the grey one). When the oscilloscope was turned off or its power cable was physically moved away from the analog input cable, the narrow spur at 60 kHz disappeared, as shown in Figure 10.

In the system cabinet, care should be taken in routing the cables from the sensor to the DAQ board. It is a good practice to keep the low level sensitive analog signals separated from the high current power lines.

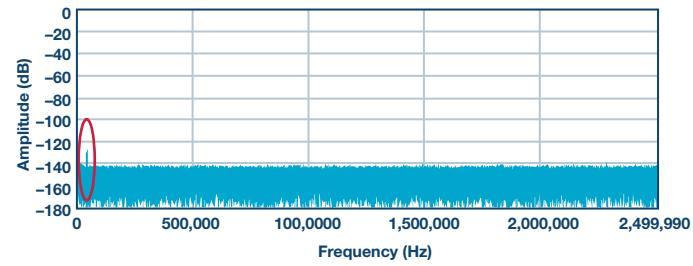
Figure 11. Spurs on EVAL-AD7960FMCZ by flourescent lighting radiation.

A spur appeared on the FFT spectrum while testing the EVAL-AD7960FMCZ evaluation board. As shown in Figure 11, the spur level was about -130 dB at 40 kHz.

The 40 kHz seemed to be unrelated to any of the signal frequencies that appear on the EVAL-AD7960FMCZ board and its controller board, SDP-H1. The next approach to finding the source of the spur was to clear the test bench in case there was something generating external interference. When the fluorescent light on the bench rack was turned off, the spur disappeared. Furthermore, it was found that as the EVAL-AD7960FMCZ board was put closer to the light, the 40 kHz spur would get higher. An additional RC filter (such as 1 k Ω , 10 nF) was placed at the front of the buffer amplifier ADA4899-1 and the spur decreased about 10 dB. That meant that the fluorescent light was radiating disturbance into the signal chain path at the front of the noninverting input of the buffer amplifier.

For systems that operate in a lighted environment, installing a shielding case over the front-end circuitry can help protect it from radiating interference and optimize signal chain performance.

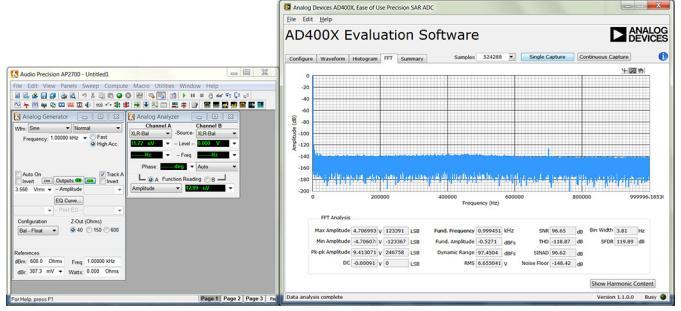
Figure 13. Spur on EVAL-AD4003FMCZ eval board caused by XLR cable.

During the evaluation of the EVAL-AD4003FMCZ board, an AP SY2712 signal generator was used to drive a low noise and low THD sine wave to the analog inputs through an XLR microphone cable (about 2 meter long). In this setup, a spur was apparent at a level of about -125 dB at 700 kHz, as shown in Figure 13.

- Bypass the two meter long XLR microphone cable and short the AP balanced output XLR male connector to the interposer XLR female connector.
- Set the signal source SY2712's output impedance from Z-Out = 40 Ω to Z-Out = 600 Ω.
- ► The spur becomes smaller when a narrow bandwidth RC filter (such as 1 k Ω , 10 nF) is inserted in the signal chain at the front end of the AD4003's buffer amplifier, the ADA4807-1.

Finally, the conclusion was reached that the mismatch in the signal source's output impedance, and the long XLR cable, caused the high frequency spur at 700 kHz.
